The Window

ON HISTORIC PRESERVATION

ARCHITECTURAL STYLES, PART 8

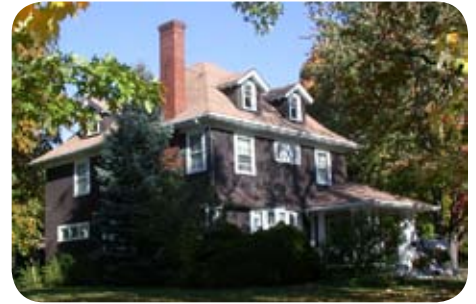
Cayuga Street

braces. Porch roof supports are typically short, square, sometimes tapered, columns resting upon masonry piers. Hipped roof variations of the Craftsman style can also be found.

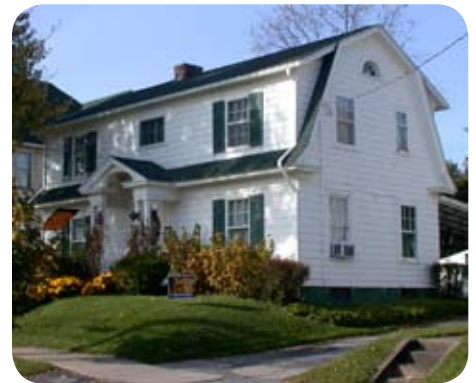
Beryl Avenue

Dutch Colonial Revival

This subtype of the Colonial Revival was most popular between 1895 and 1950 and is distinguished by its steeply pitched gambrel roof. Locally, side gambrels were prevalent in the 1920s and 1930s. Unlike original Dutch Colonial, the revival style houses usually feature separate dormer windows or a continuous shed dormer across the front. Federal style entries are often found, sometimes beneath a separate roof or a full-width porch. Early examples were commonly built with front-facing gambrels and included cross gambrels at the rear.

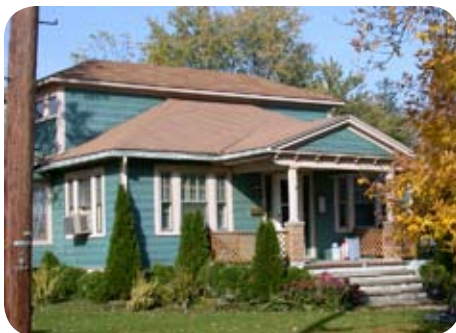
Maynard Street

Originating in southern California, the Craftsman style was primarily influenced by the Arts and Crafts movement. Between 1905 and 1930 pattern books

and magazines contributed to the national popularity of Craftsman houses, from simple bungalows to more elaborate variations. In the northeast United States the side-gable bungalow became the most popular subtype. They usually feature porches contained under the main roof, which often sports a centered dormer. The eaves are rarely boxed, displaying exposed rafter tails and decorative beams sometimes supported by triangular knee

Craftsman
